Ameni Adli et al. (2021), Esthetic and Functional Restoration of A Compromised Central Incisor: A Case Report
Int J Dent & Ora Hea. 7:10, 120-122

Rapid Communication

Esthetic and Functional Restoration of A Compromised Central Incisor: A Case Report

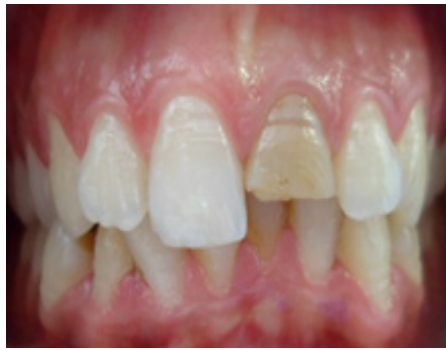
A 22-year-old male patient with a compromised maxillary central incisor was referred by the department of endodontics. His left central incisor is horizontally fractured at the mid-third of the discolored crown. The patient reported he was victim of a traumatic incident many years previously (figure 1) and the tooth has been endodontically treated since then.

Figure 1 : Intraoral frontal view showing discolored fractured central incisor

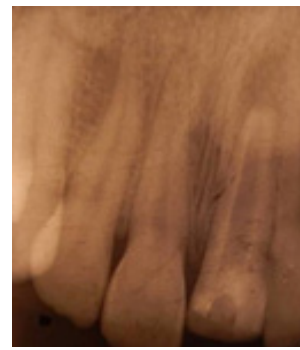
The periapical radiograph done the first time he visited the department of conservative dentistry shows incomplete root edification (figure 2). The formation of an apical barrier was necessary in order to fill the root canal system without risk of overfilling. Therefore the large canal was filled to the mid-third with biodentine and the rest of the canal was filled with gutta percha (figure 3).

Figure 2 : Initial periapical radiograph

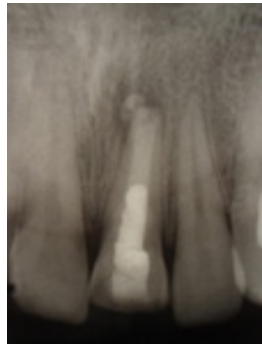
Figure 3: Periapical radiograph after treatment in department of restorative dentistry

Biodentine, is a biologically active cement which has dentin-like mechanical properties and can be used as a dentin replacement in the tooth crown and root region. The cement consists mainly of a tri- and dicalcium silicate powder, which is mixed with an aqueous calcium chloride solution. Appreciable properties of biodentine includes good physical properties and its ability to stimulate tissue regeneration as well as good pulp response. It has great potential to revolutionise the different treatment modalities in paediatric dentistry and endodontics especially after traumatic injuries.

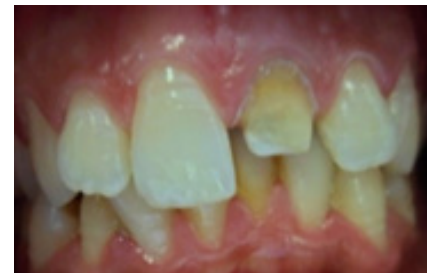
Figure 4 : Intraoral view after tooth preparation

The tooth preparation is done with juxta gingival finish line (figure 4). Composite is used to extend the clinical tooth length (figure 5). Then a temporary crown was made and sealed with eugenol free temporary cement (figure 6).

Both of The significant overbite (overbite = 5mm) and the insufficient height of the abutment led us to indicate an emax crown. Finishing line is then carried out supragingival to allow bonding which will improve the retention of the restoration.

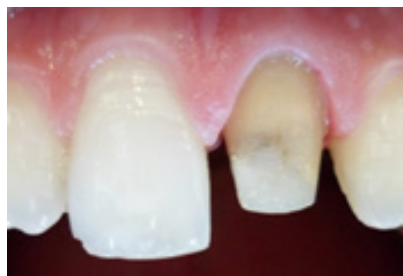
Figure 5: Intraoral view after length crown augmentation with composite

Due to the fracture the abutment presents an insufficient height. Glass fiber post and core is not possible because of the large width of the canal as well as the presence of biodentine which occupies more than half of the canal height. We tried adding composite at the incisal edge of the tooth but we were limited by the eccentric movement of the mandible.

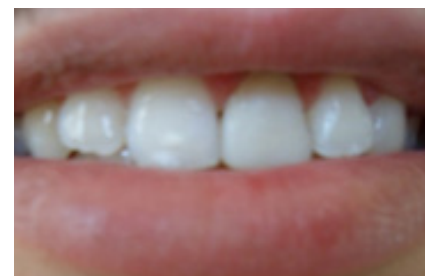
Figure 6: Patient smile with provisional crown

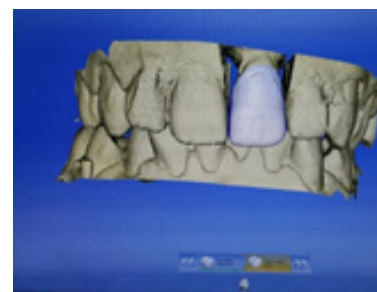
Figures 7-8-9 : Virtual conception of the crown

When designing the e max crown, a symmetry with the right central incisor is achieved. As for optical outcome, a try in paste is used to check the final result before bonding. In fact, optical outcome vitro-ceramic crowns is not limited to restoration color, but it also depends on the thickness of the ceramic core, the surface state, the assembly method and materials and the color of underlying substrate. Once the patient is pleased with the result, the crown is bonded.

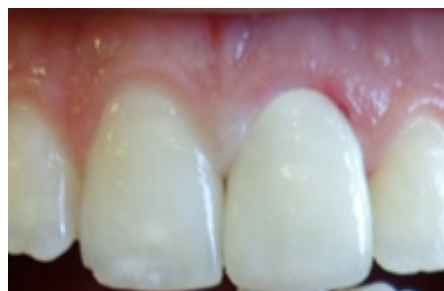
Figure 10 : Final result
